MsS Inspection of Twisted Heat Exchanger Tube

Southwest Research Institute

August 2008

1" OD, 0.085" Wall and 43" long Twisted S.S Tube Sample

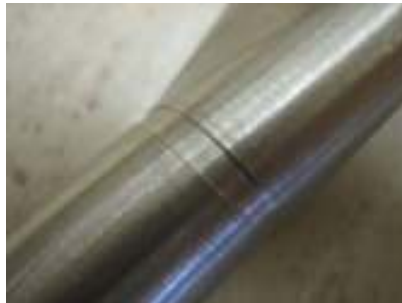
Defect A
0.1 x 0.0075"
circumf. groove
9% CSA
at 16" from the
sensor end

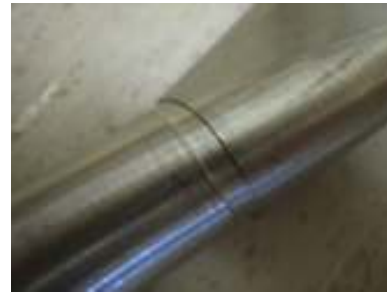
Defect B
0.1 x 0.015"
circumf. groove
18% CSA
at 20" from the
sensor end

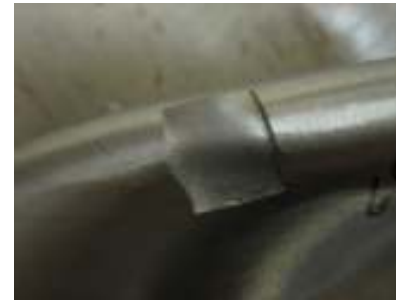
Defect C
0.32x0.4x0.065" max
notch
5% CSA
at 24" from the
sensor end

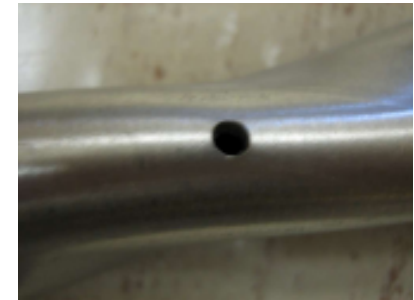
Defect D
0.125" hole
4 % CSA
at 28" from the
sensor end

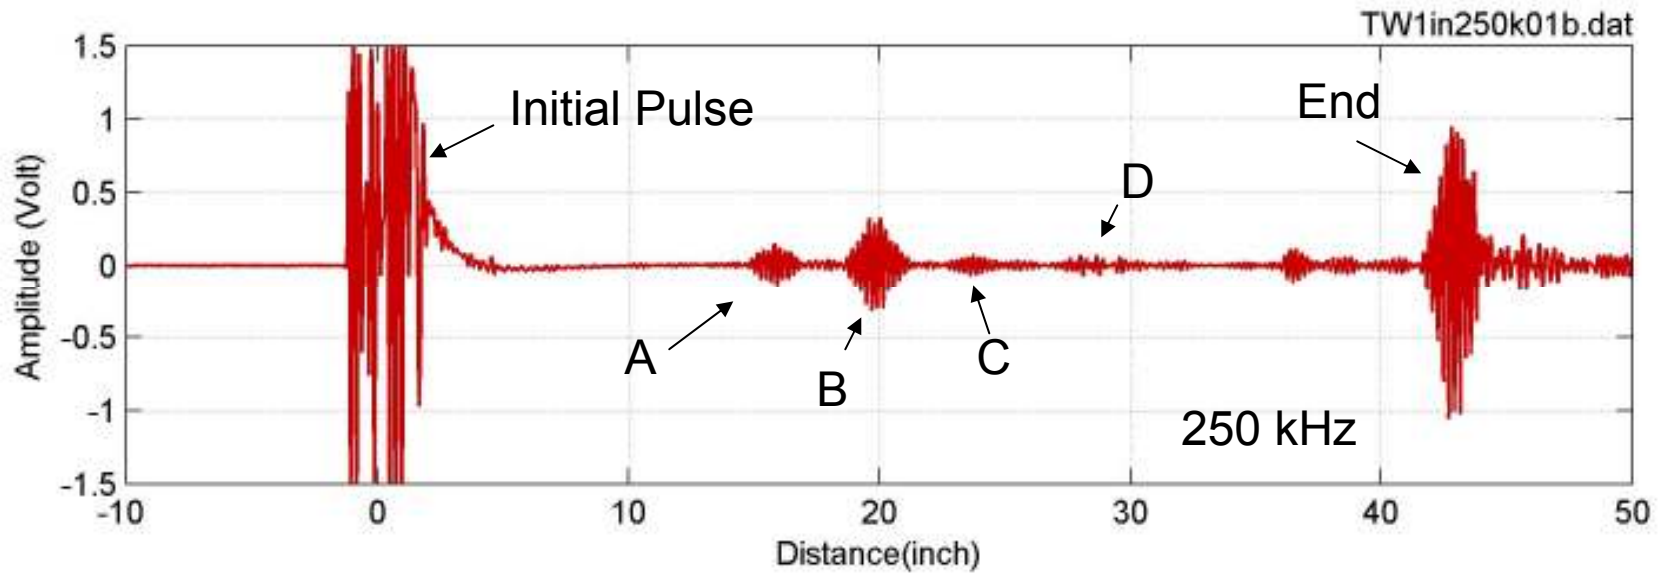
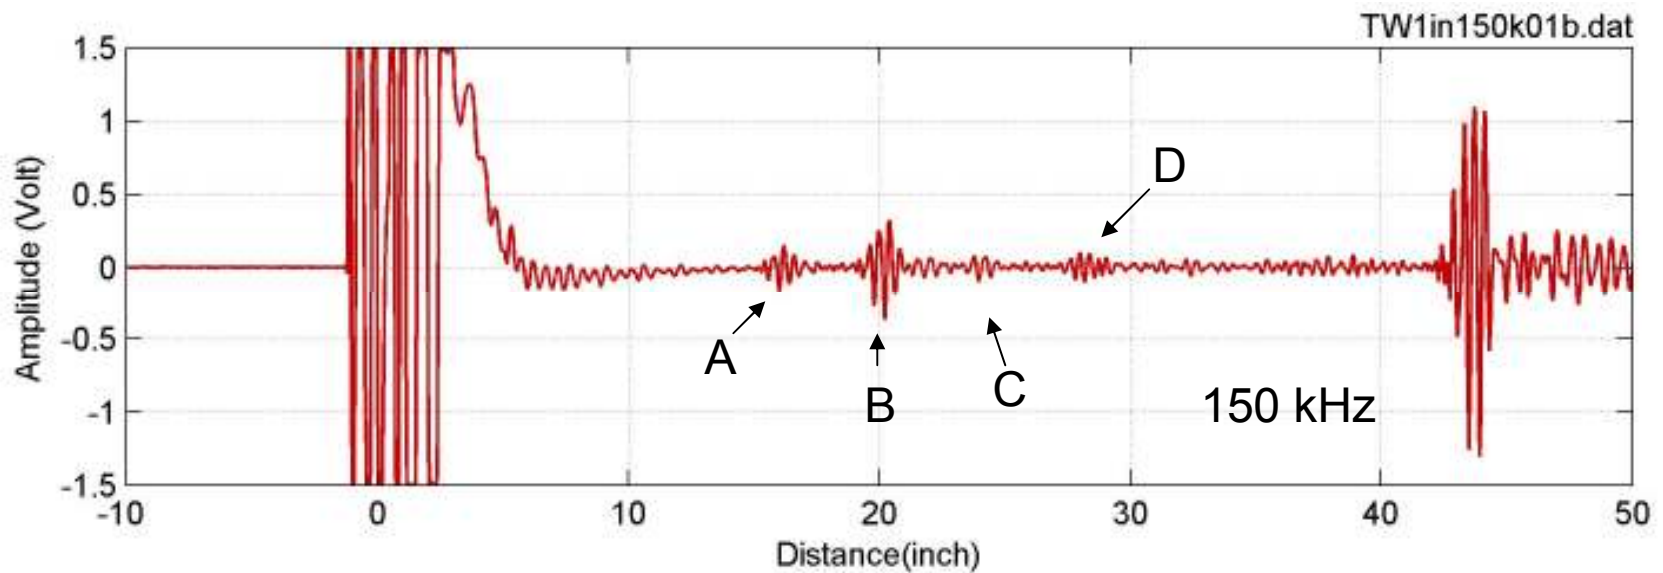
MsS T-Mode Data from 1"OD, 0.085"wall Twisted S.S Tube

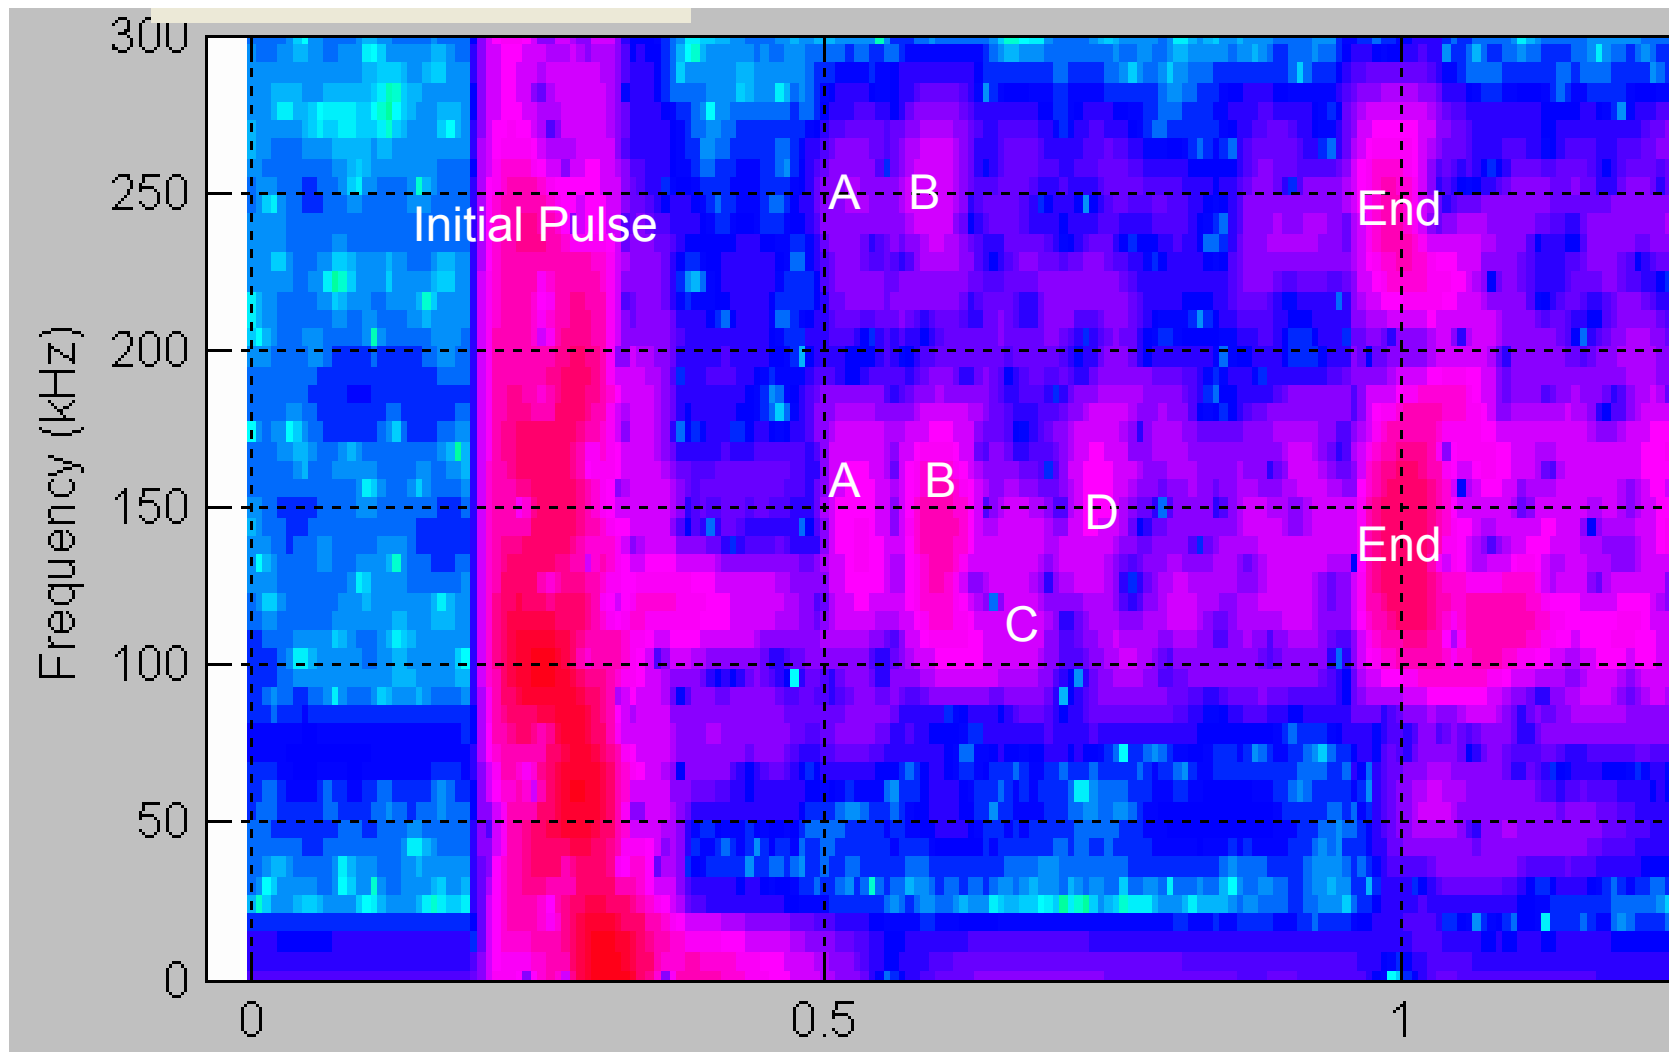
T-Mode Dispersion Properties in the Test Sample

Cutoff frequencies at approximately 75 and 200 kHz that were caused by the twisted geometry
